Ca' Foscari
University
of Venice

Final Thesis

**A significant contribution to the
conservation of UNESCO sites in
Armenia. Study of the state of
conservation of the Geghard Monastery**

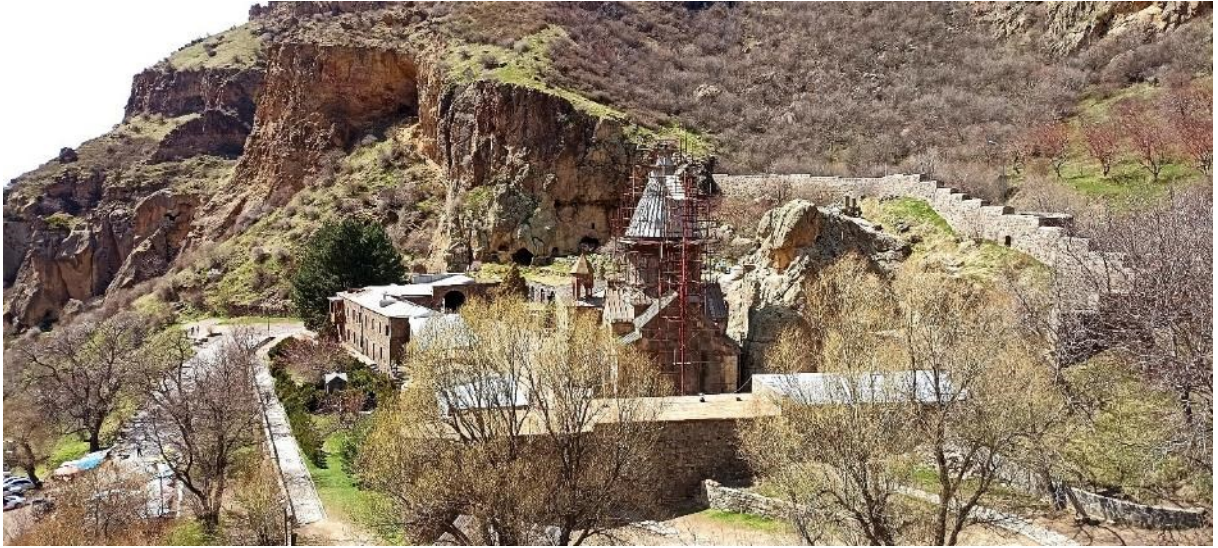
Figure 1. The monastic complex of Geghard.

The Geghard monastery (Fig. 1) is one of the three cultural heritages of Armenia registered in the UNESCO Heritage list. This, along with its proximity to the capital Yerevan (42 Km), the particular architecture largely carved into the rock and the fact that still is a consecrated church, makes it one of the most visited monasteries in the territory. However, despite the importance of this monastic complex, diagnostic studies for its conservation are practically absent. For this reason, the preliminary investigations carried out for this thesis work result to be of fundamental importance.

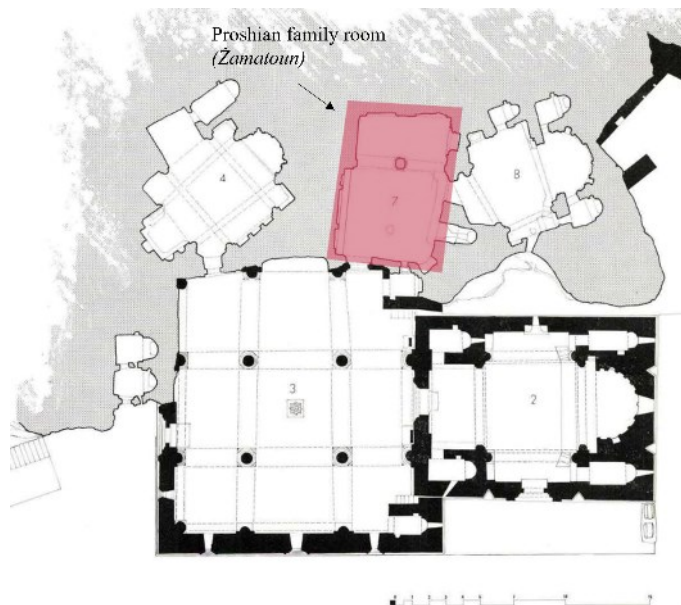
Figure 4. First floor planimetry of Geghard Monastery, highlighted the Proshian family room (*Žamatoun*) (by Ara Stepanian, Telman Gevorgian, Edik Hovhannisian, Hratchia Gasparian & Edward Frangoulian, 1971).

The Proshian family room is the area where most of the investigations conducted during this thesis work were done (Fig. 4). This choice is linked to the analyses that were already carried out in 2019 during the summer school organized by the National University of Architecture and Construction of Armenia (NUACA), and the willingness to compare what was found in the past and eventually upgrade it. In 2019 indeed a damage assessment of the western wall of the *Žamatoun* was carried out resulting in a degradation map. This last, even though does not follow the standardized ICOMOS glossary, could be useful anyway to understand how the situation has changed over the years. For this reason, the research area is taken under consideration in the most recent analysis.

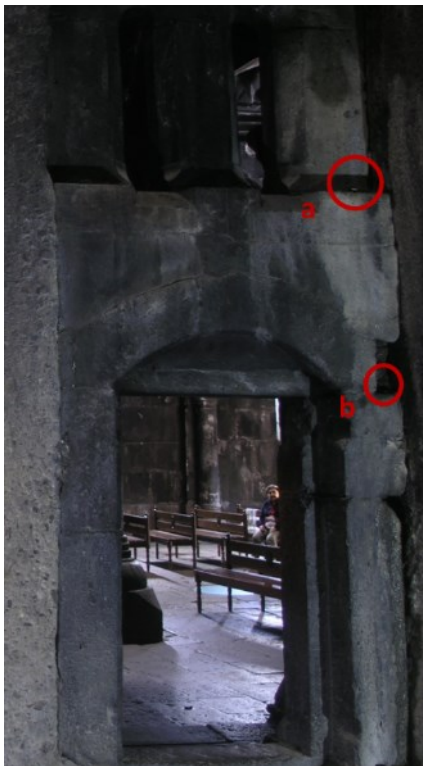
Figure 6. Localization of the dataloggers. a) first datalogger position; b) second and lost datalogger position.

Additionally, to have more appropriate and representative results that can be compared with the room under analysis, the ideal would be to have the measurements for an entire year. This allows us to have a good general idea of the temperature fluctuations that could be related in some ways to the internal degradation processes that are going on. However, all these requirements and suggestions cannot always be applied, as in the case of the Geghard Monastery where the lack of appropriate surveillance, does not permit keeping the instrument wherever necessary. In fact, initially, there was another datalogger placed at $\pm 1,5$ m but that disappeared after a few days causing the impossibility of having more precise results (Fig. 6).

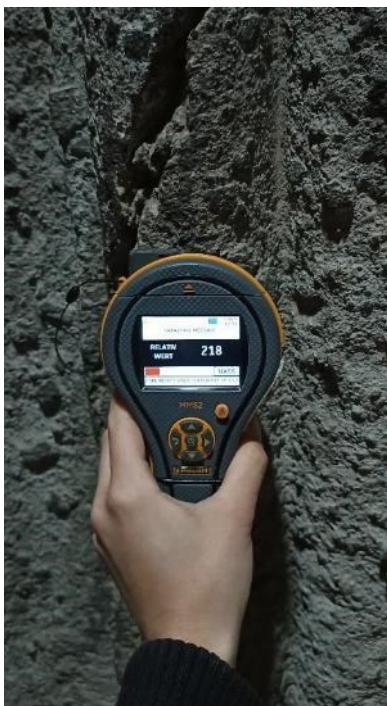
Figure 7. Application of Protimeter MMS2 in "Pinless Moisture Meter" mode.

In the Proshian family room, the instrument used for a semi-quantitative distribution of the water is the *Protimeter MMS2* provided by NUACA University with the "Pinless Moisture Meter" mode (Fig. 7). This instrument gives RH measurements ranging from 60-999 according to which the material is considered:

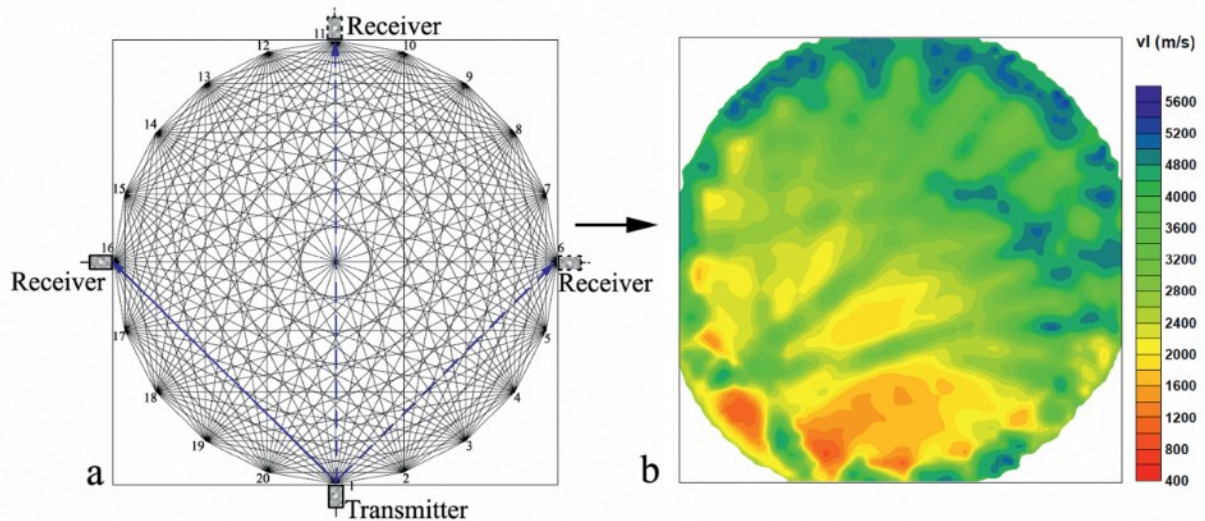
Figure 8. Ultrasonic tomography measurement. a) Scheme of the measurement points for the tomographic reconstruction of a section of a column; b) Tomogram for one stone section with the distribution of ultrasonic velocities (Ahmad, Pamplona, & Simon, 2014 [24]).

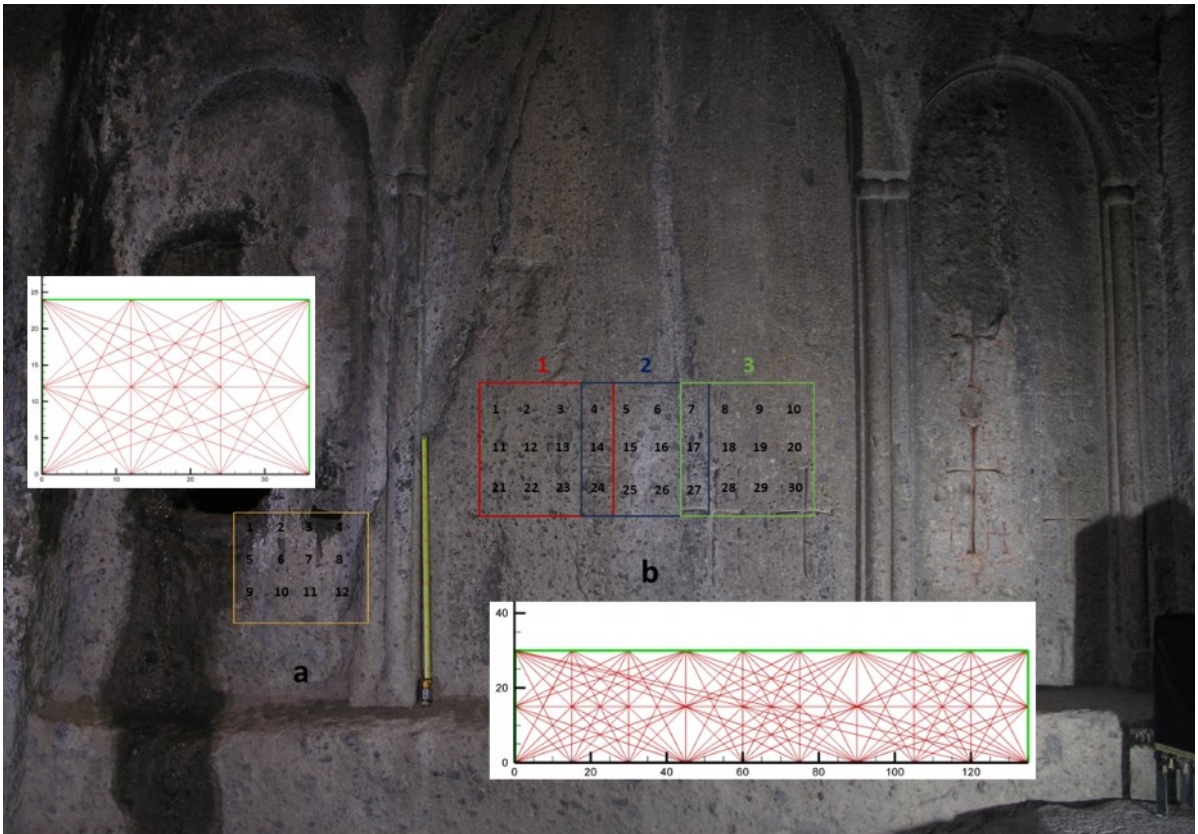
Figure 9. Points where the ultrasonic analyses were carried out on area "a" and "b" with the correspondent analysed paths.

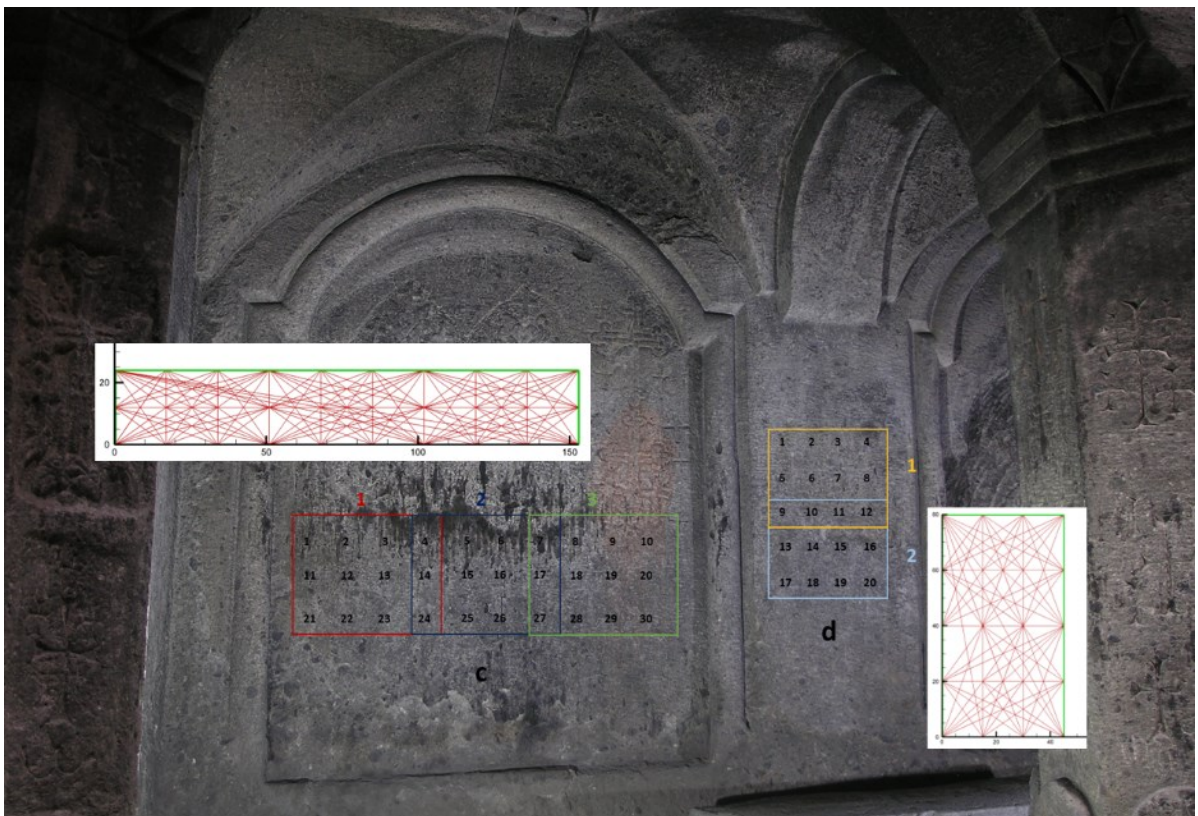
Figure 10. Points where the ultrasonic analyses were carried out on area "c" and "d" with the corresponded analysed paths.

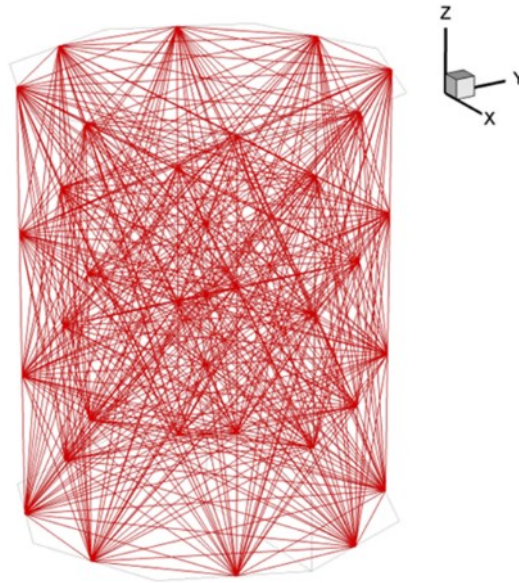
Figure 11. Column paths for ultrasonic analyses.

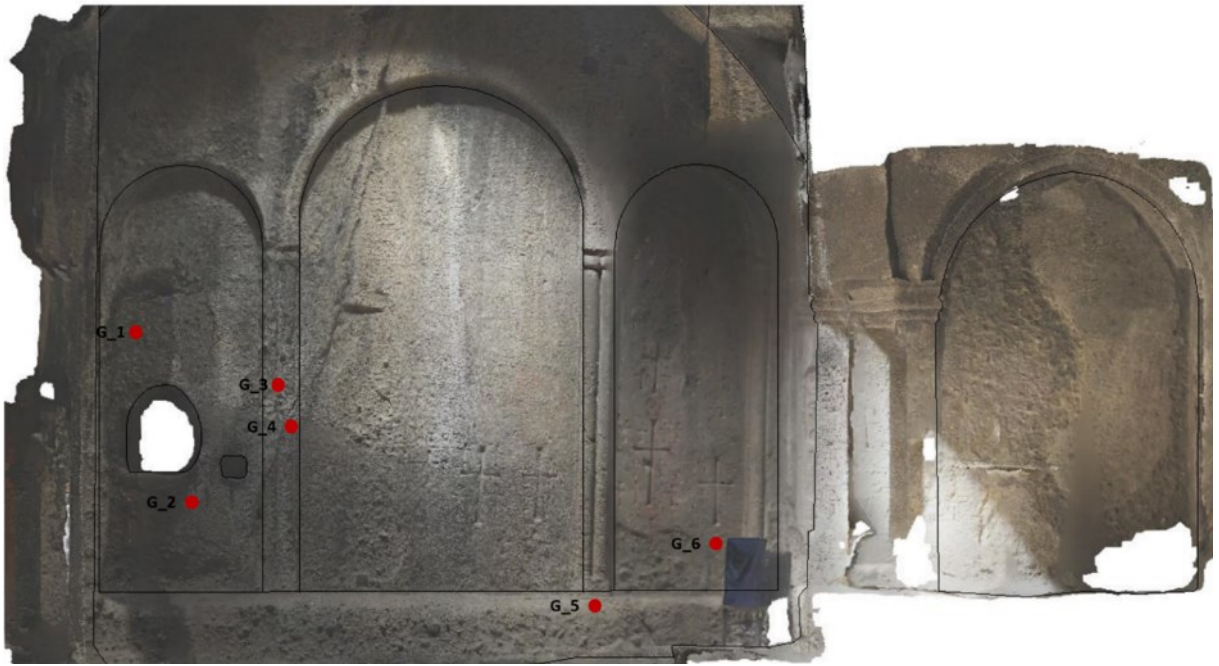
Figure 12. Sampled points on the Proshian family room western wall.

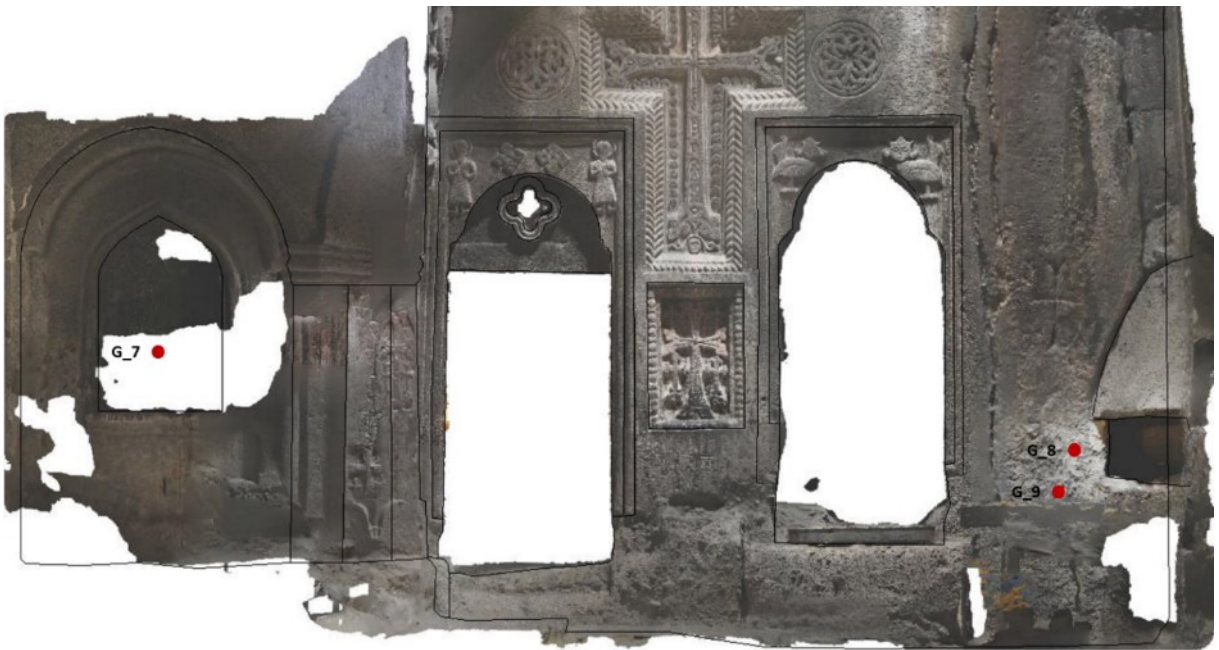
Figure 13. Sampled points on the Proshian family room eastern wall.

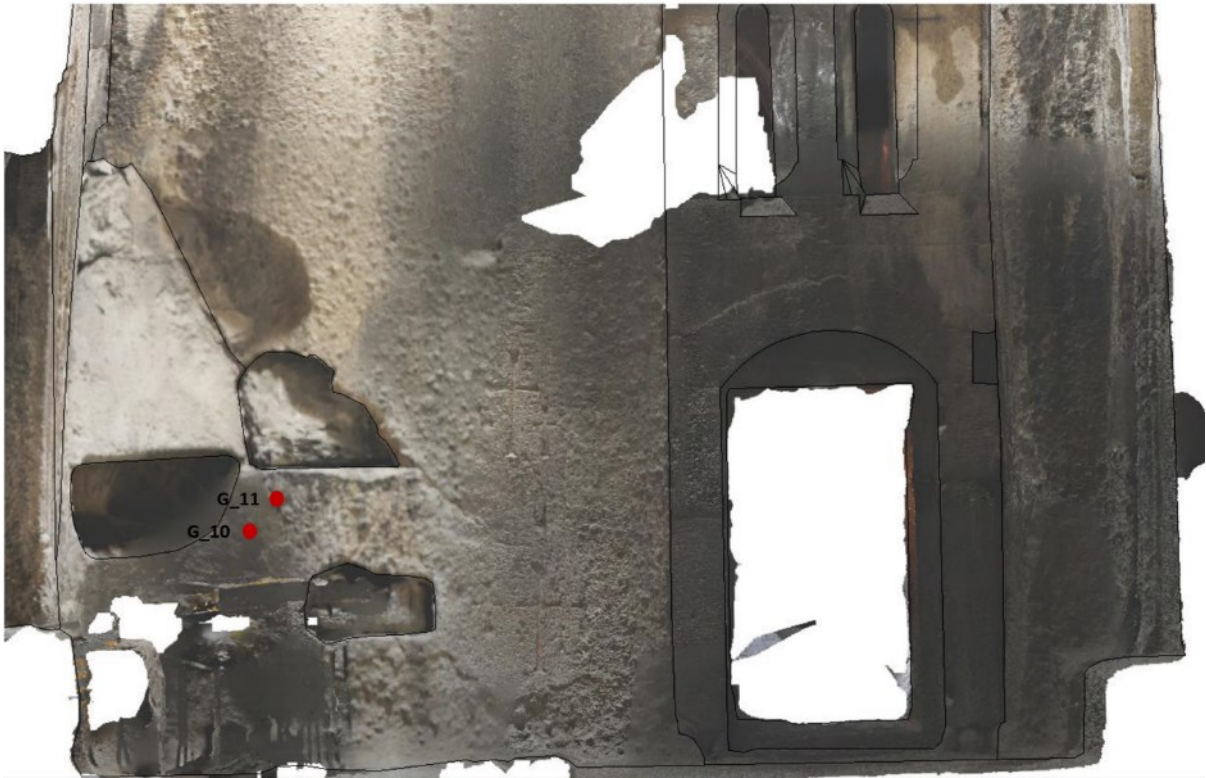
Figure 14. Sample points on the Proshian family room southern wall.

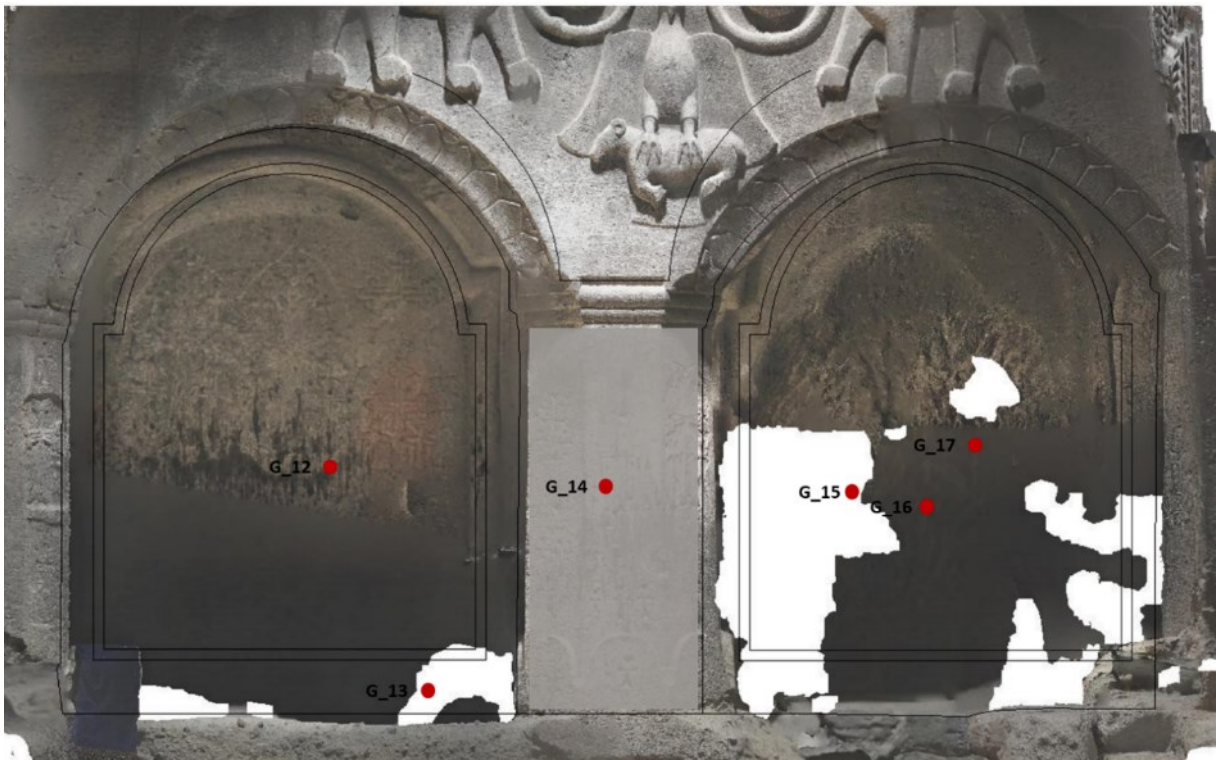
Figure 15. Sampled points on the Proshian family room northern wall.

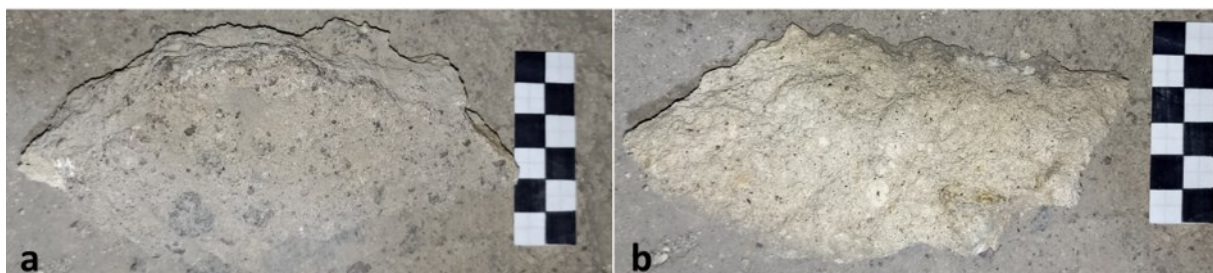
Figure 17. G_5 sample. a) surface of the sample; b) bottom part of the sample.

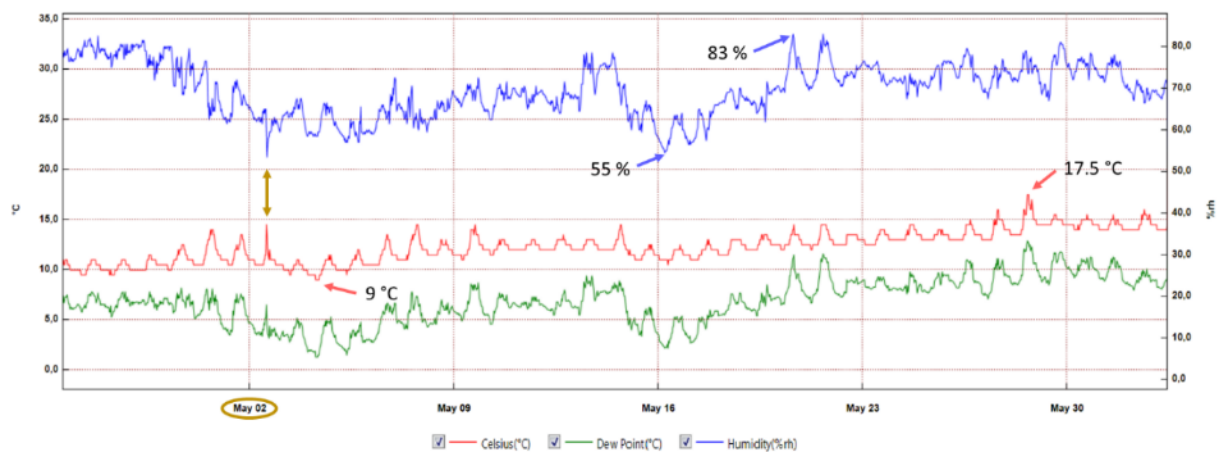
Figure 18. Environmental monitoring results from 04/25/2023 to 06/02/2023.

The result of environmental monitoring of the Proshian family chamber is reported in Figure 18.

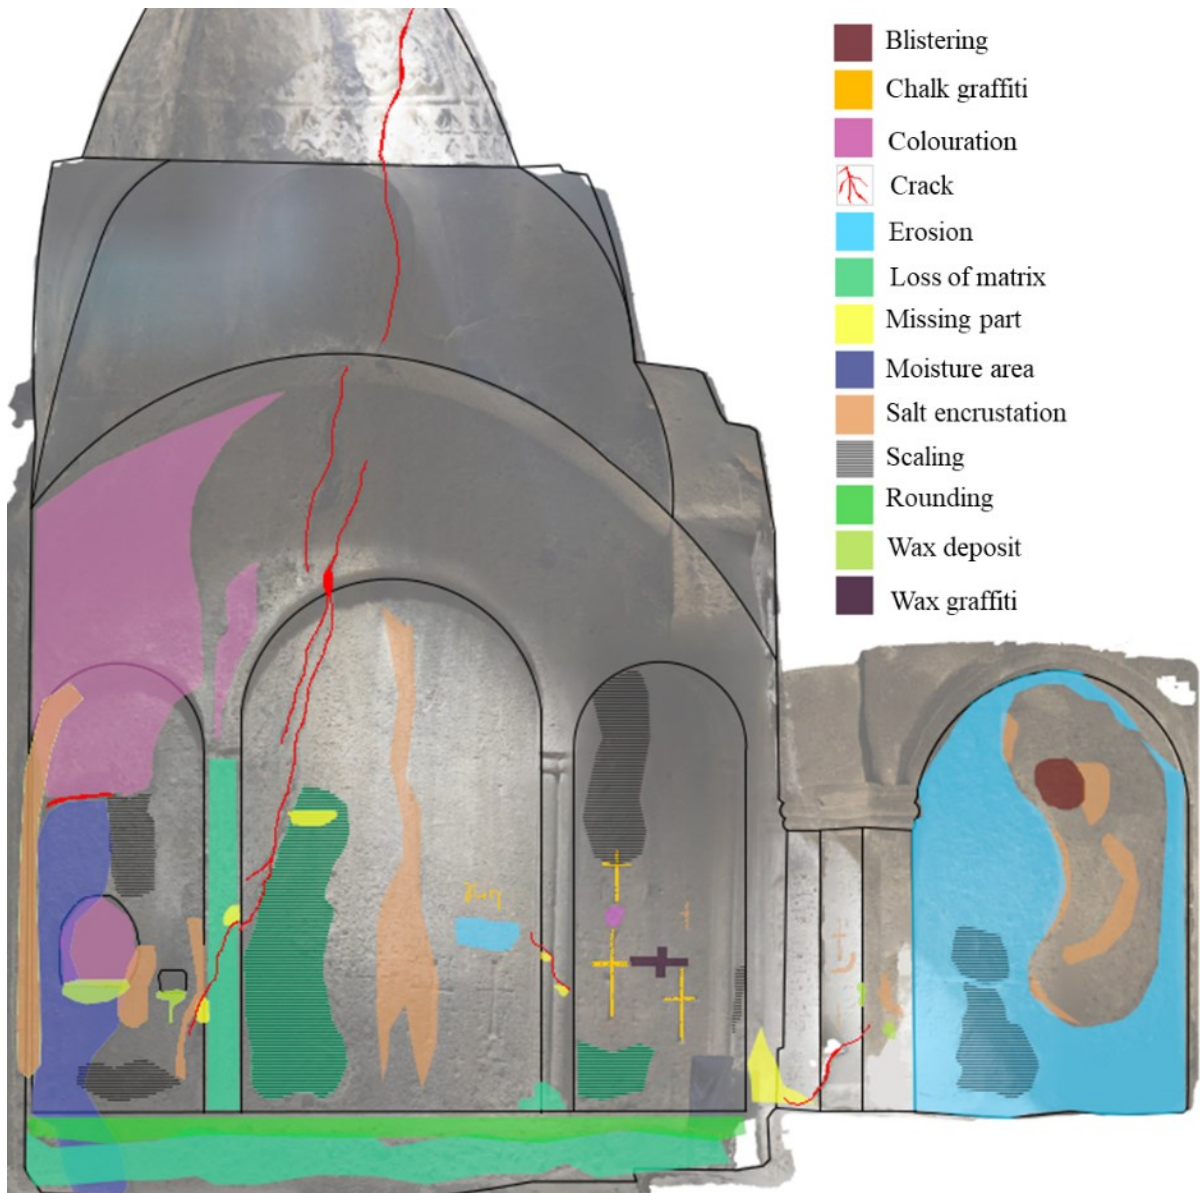
Figure 20. Degradation map correspondent to the western wall of the Proshian family room.

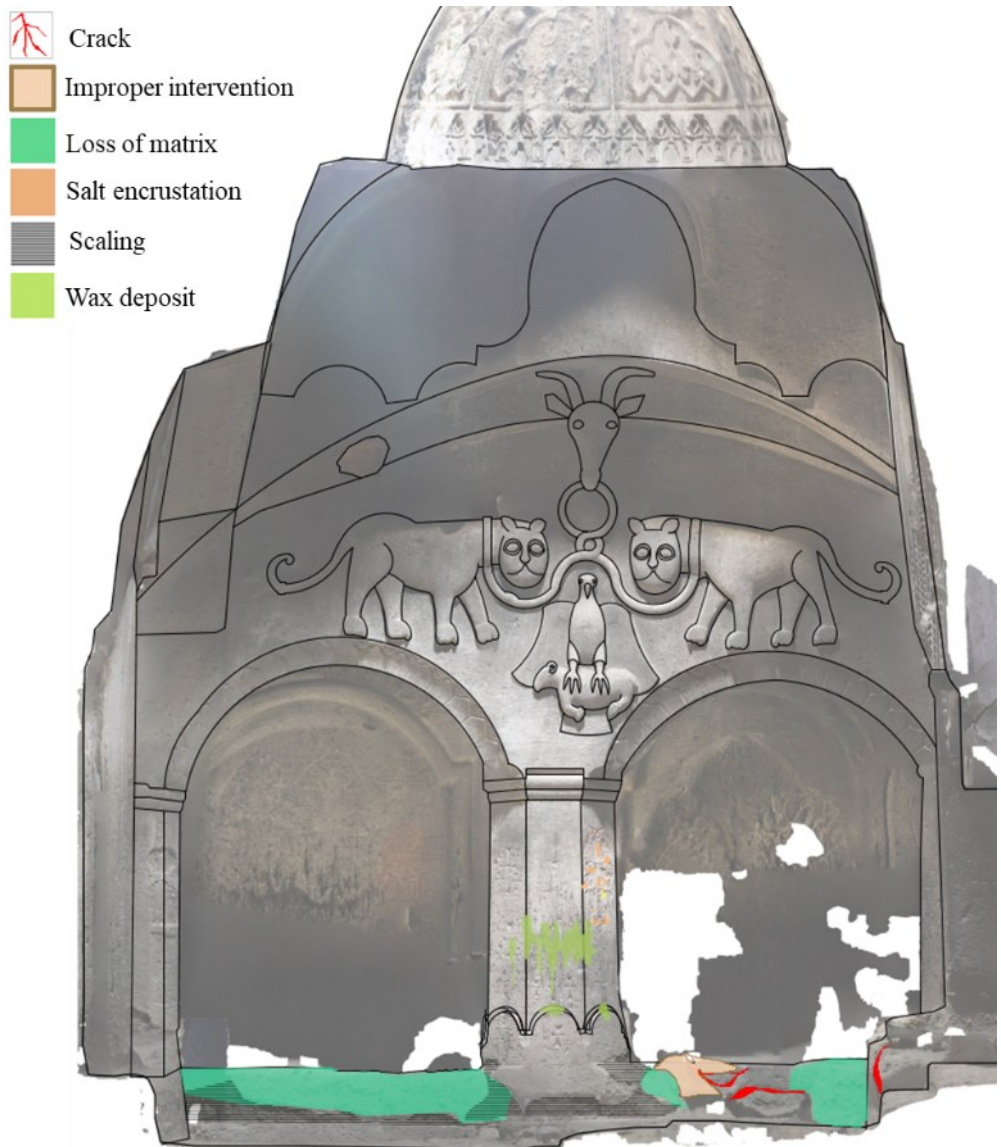
Figure 21. Degradation map of the octagonal colomun and base of the Proshian family room (view from the centre of the chamber).

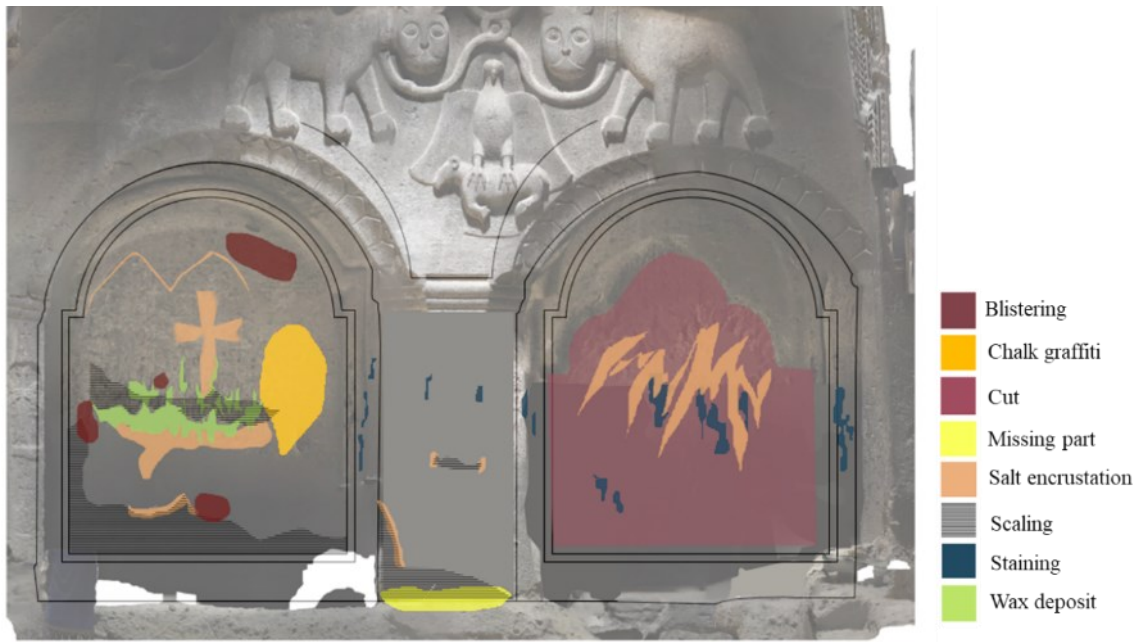
Figure 22. Degradation map of the northern wall of the Proshian family room.

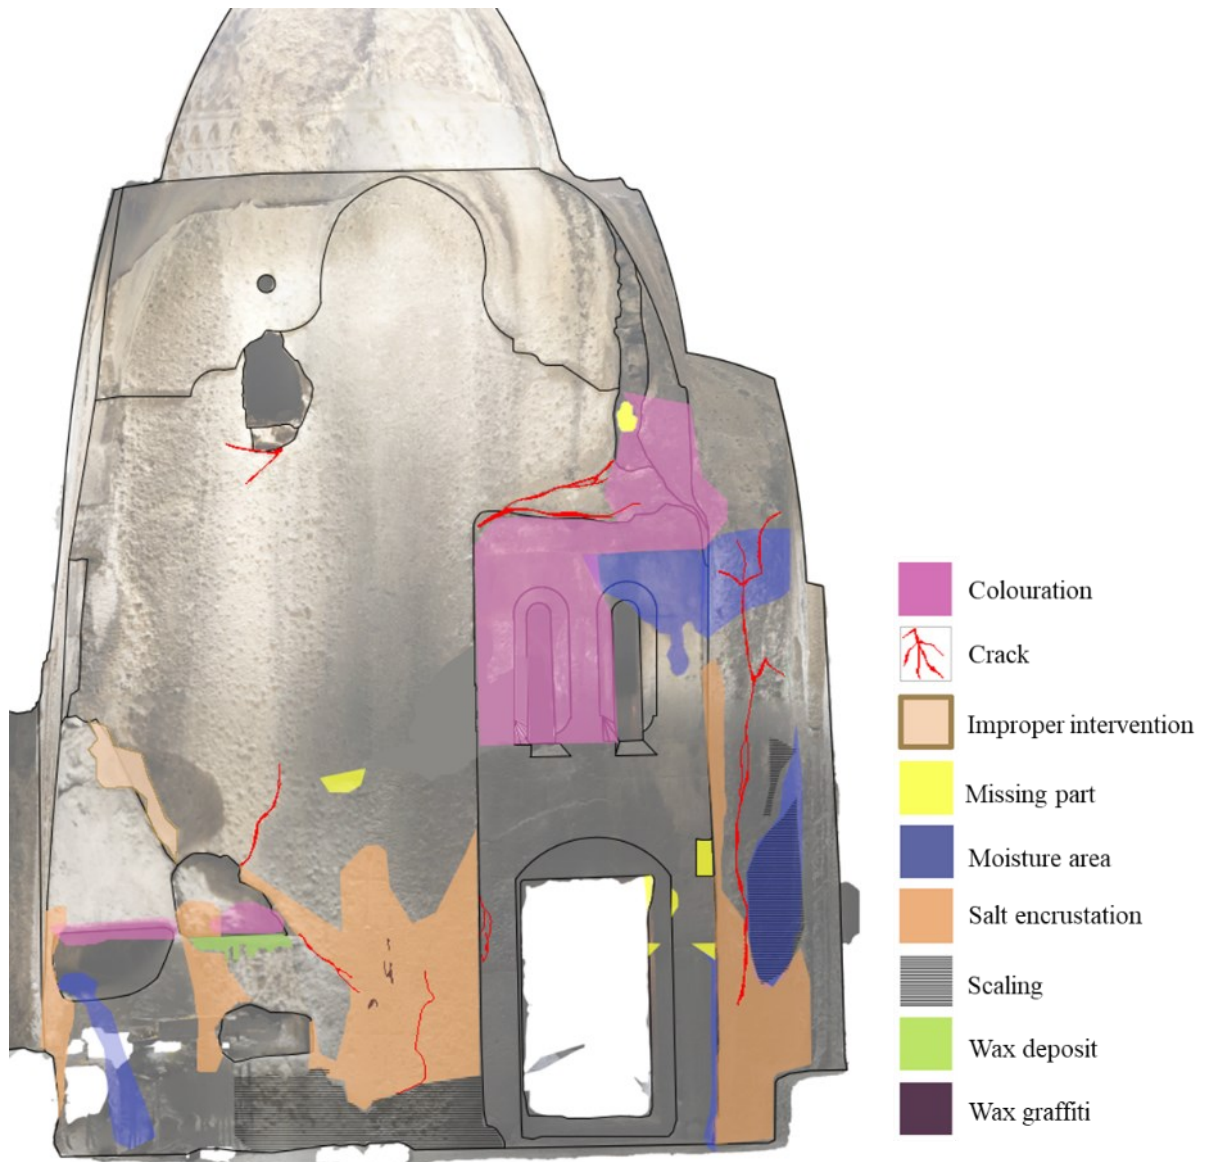
Figure 24. Degradation map of the southern wall of the Proshian family room.

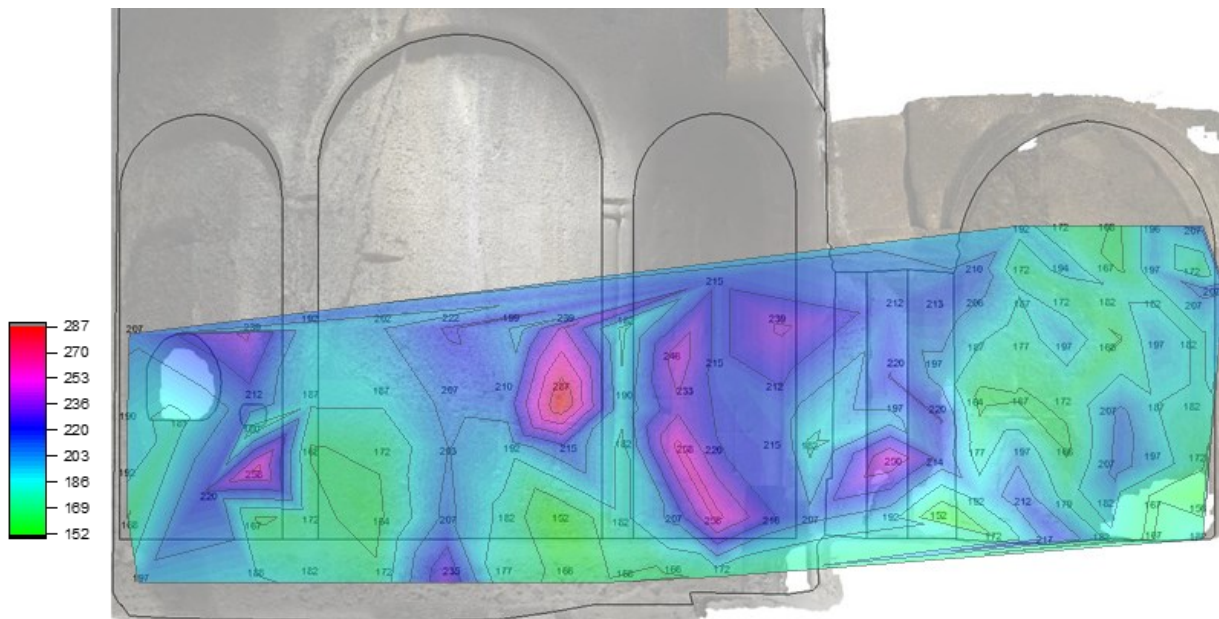
In the map corresponding to the Proshian family's west wall (Fig. 25) the minimum value is equal to 152 and the maximum to 287. According to the values of the manual of the instrument used, we thus have that between 152 to 170 we should deal with dry conditions, from 170 up to 200 we should be in a risky situation and for those that go from 170 to 287 we should have a wet area. In this map, some points are more evident, and we can notice how there is not a gradient difference between the bottom and high parts. It does not seem that there is a relationship with rising damp but there are located areas that suffer more than others. Anyway, these results seem to be odd since do not really reflect the real situation, for instance: in the left arc beneath the "window" there is constantly an evident moisture area with water that comes out from an upper fracture; theoretically, the value result should be equal to the maximum (999), but this is not clearly happening even though more measurements were taken. This is just an example, but it was one of the main reasons why the efficiency of the used tool was questioned.

Figure 25. Colour map based on the surface humidity results with Protimeter MMS2 on the western wall of the Proshian family room.

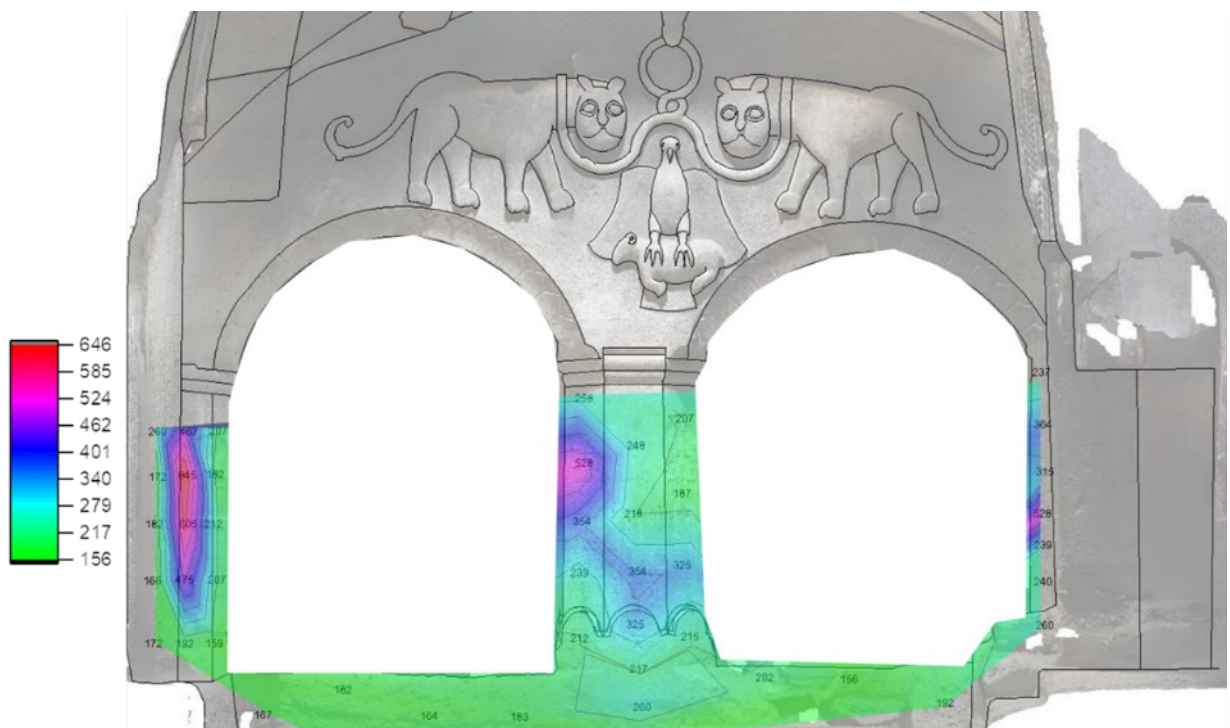
seem to be a different material too. It is reminded that in accordance with the few literature sources available about the Geghard monastery [9, 10], there should be two different main kinds of stones: tuff and basalt. As specified by Wedekind et al., each of these two kinds of rocks is differentiated in turn into two different typologies: one with higher porosity values and one with lower porosity values. For basalt, the lower porosity kind has values equal to 17,4 % while the other one has values equal to 23,5 %. For tuff, the lower one corresponds to 30 % in porosity while the higher one corresponds to 38,8 %. Even though there are no sources that really indicate which one is what, we can suppose that the basalt is the one in correspondence with the column and the sculpted zones since it is characterized by a darker colour and more visible compactness. The tuff instead could be the one characterizing the base featured by a visible heterogeneity.

Figure 26. Colour map based on the surface humidity results with Protimeter MMS2 on the columns and base of the Proshian family room (view from the centre of the chamber).

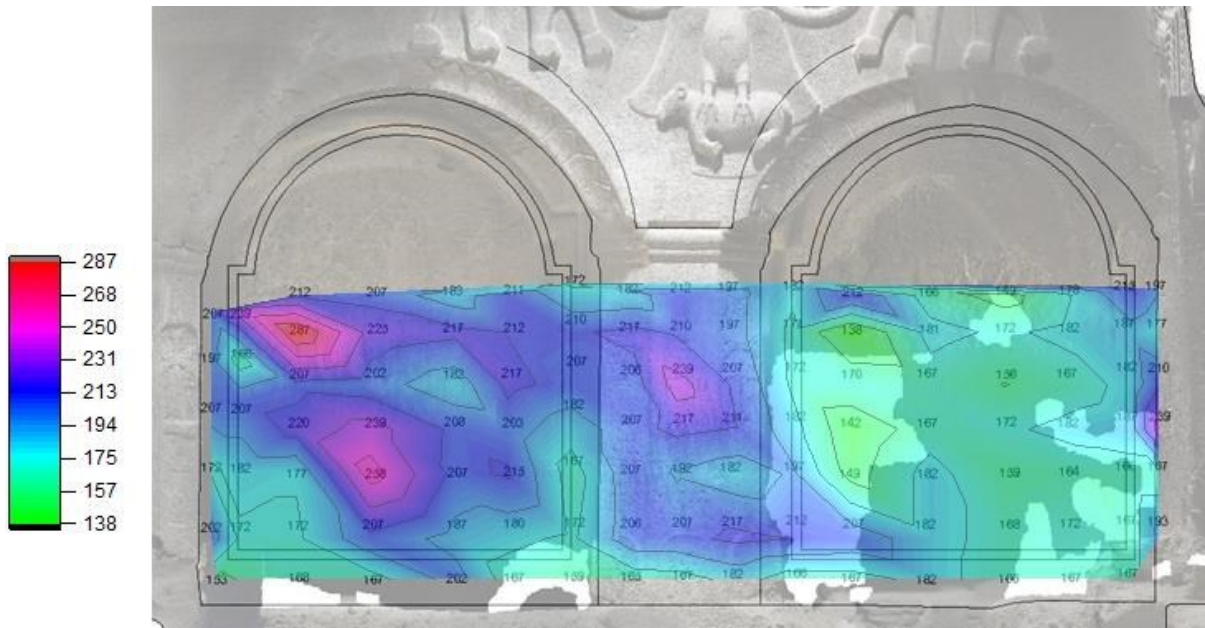
In the northern wall (Fig. 27), the surface humidity results go from 120 up to 287. Therefore, compared to the other areas, it is possible to observe some localized higher points but a distribution much more homogeneous. This may be related to the fact that this part is adjoined directly and only with the live rock, and it is less in contact with the visitors who tend to stay around the centre of the room; something that in the other areas – even though some still carved – does not occur considering that they are adjacent to other rooms and are strictly in contact with visitors too.

Figure 27. Colour map based on the surface humidity results with Protimeter MMS2 on the northern wall of the Proshian family room.

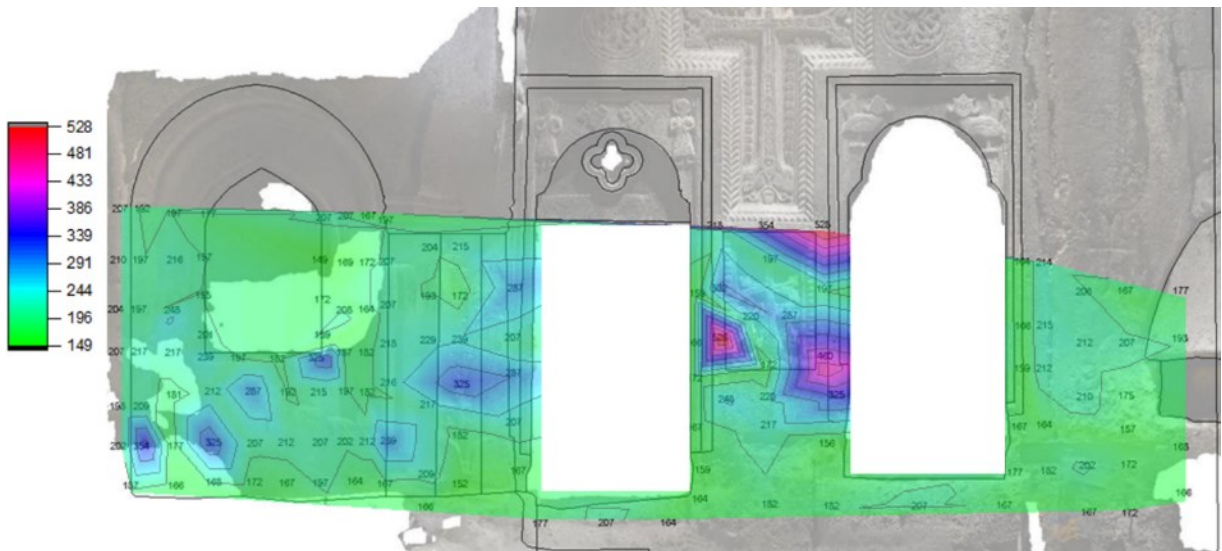
Confirming what has just been said in Figure 28 we can observe the colour map of the eastern wall of the Proshian family chamber which is adjacent to another room of the monastery. In fact, the resulting values measured go from 149 to 528: a bigger difference compared to the previous result of the northern wall (Fig. 27). Localized higher points are still present, and just few points are under 170 (value that marks the “at risk” situation).

Figure 28. Colour map based on the surface humidity results with Protimeter MMS2 on the eastern wall of the Proshian family room.

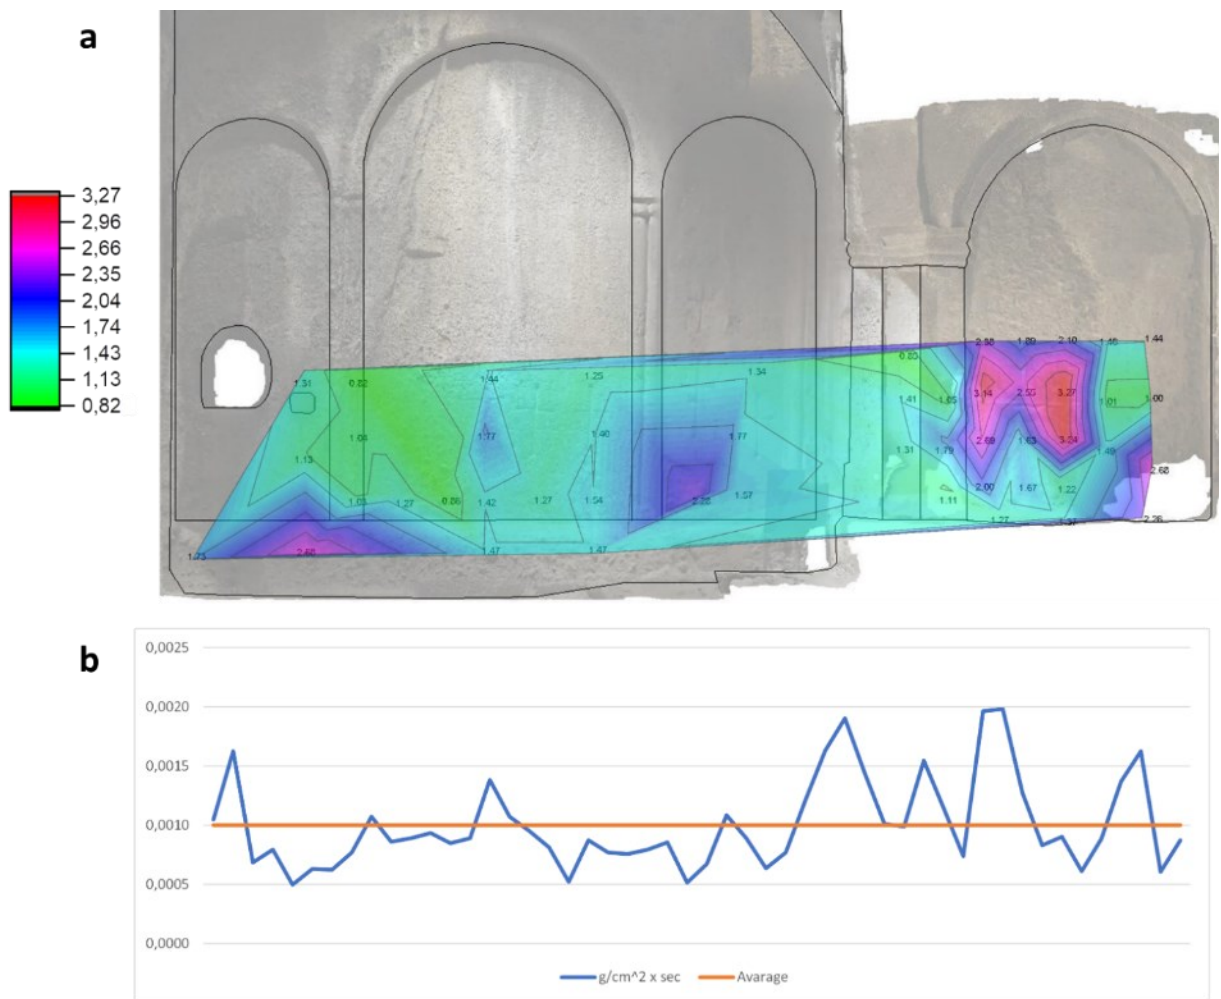
Figure 31. Western wall of the Proshian family room. a) Colour map based on the sponge-test measurements; b) Resulted values reported in $g/cm^2 \cdot sec$.

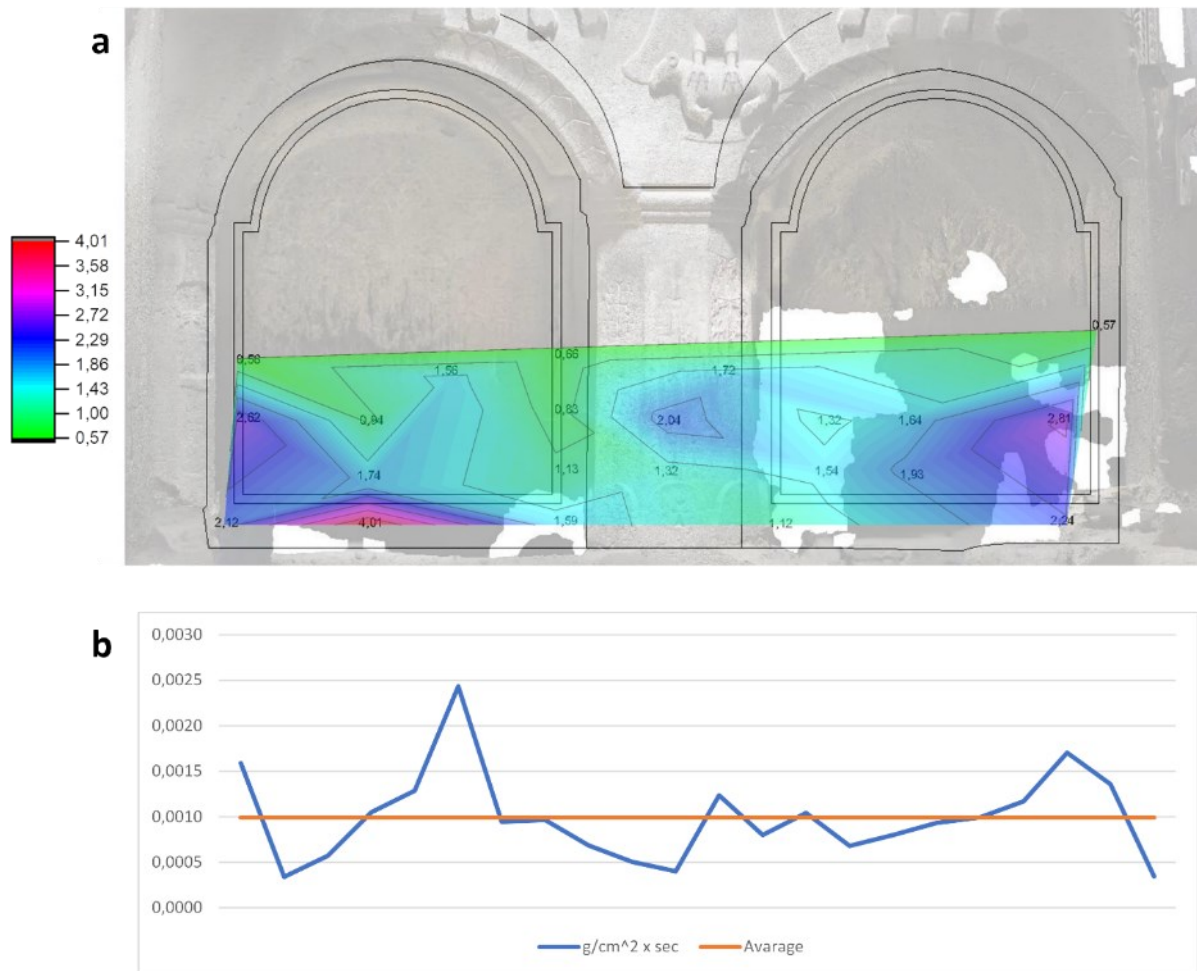
Figure 33. Northern wall of the Proshian family room. a) Colour map based on the sponge-test measurements; b) Resulted values reported in $\text{g/cm}^2 \cdot \text{sec}$.

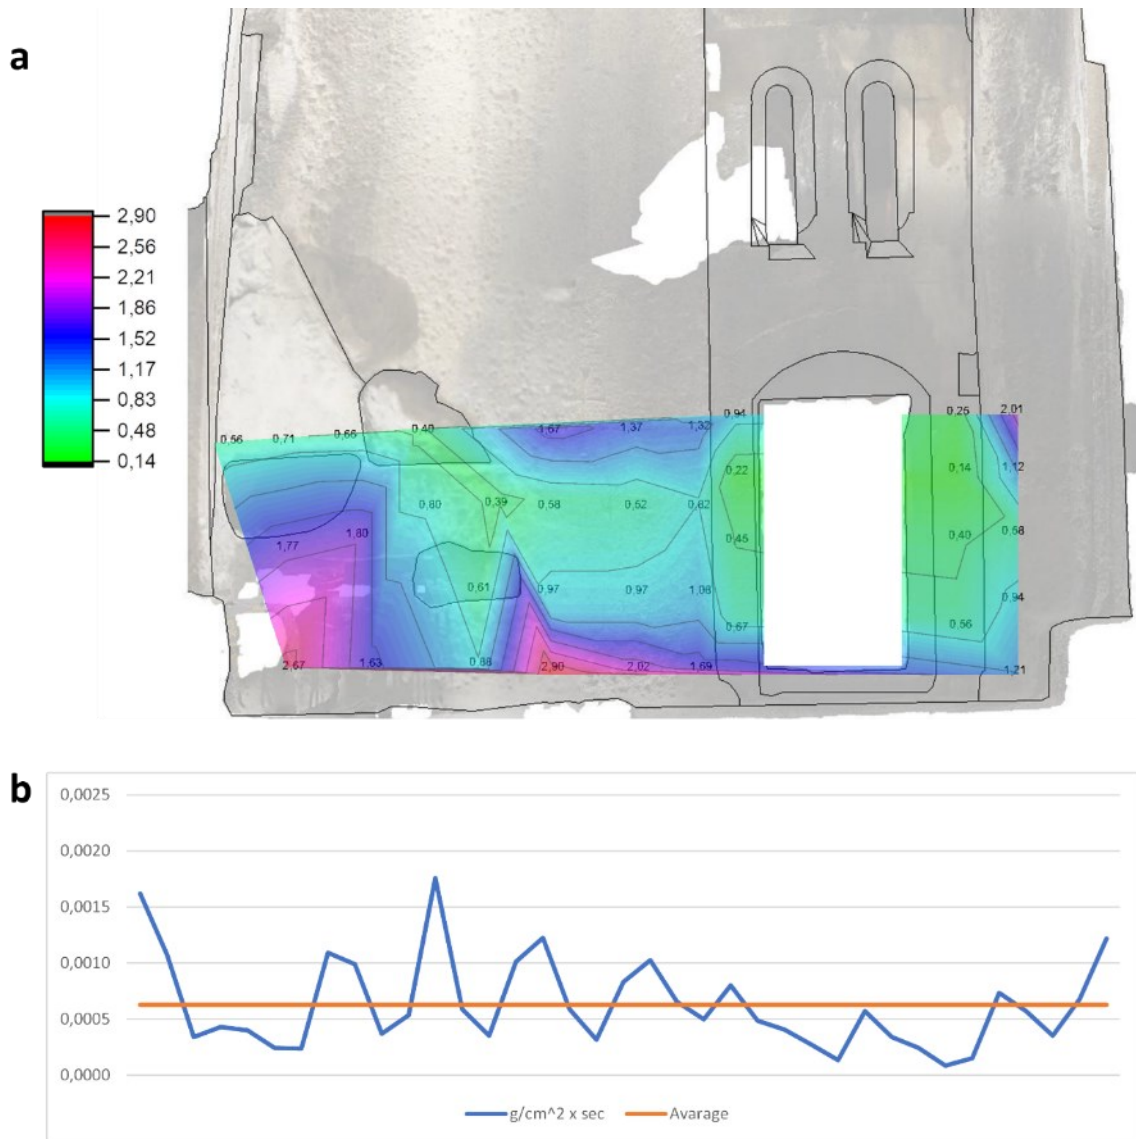
Figure 35. Southern wall of the Proshian family room. a) Colour map based on the sponge-test measurements; b) Resulted values reported in $\text{g/cm}^2 \cdot \text{sec}$.
