Ca' Foscari
University
of Venice

Final Thesis

**A significant contribution to the
conservation of UNESCO sites in
Armenia. Study of the state of
conservation of the Geghard Monastery**

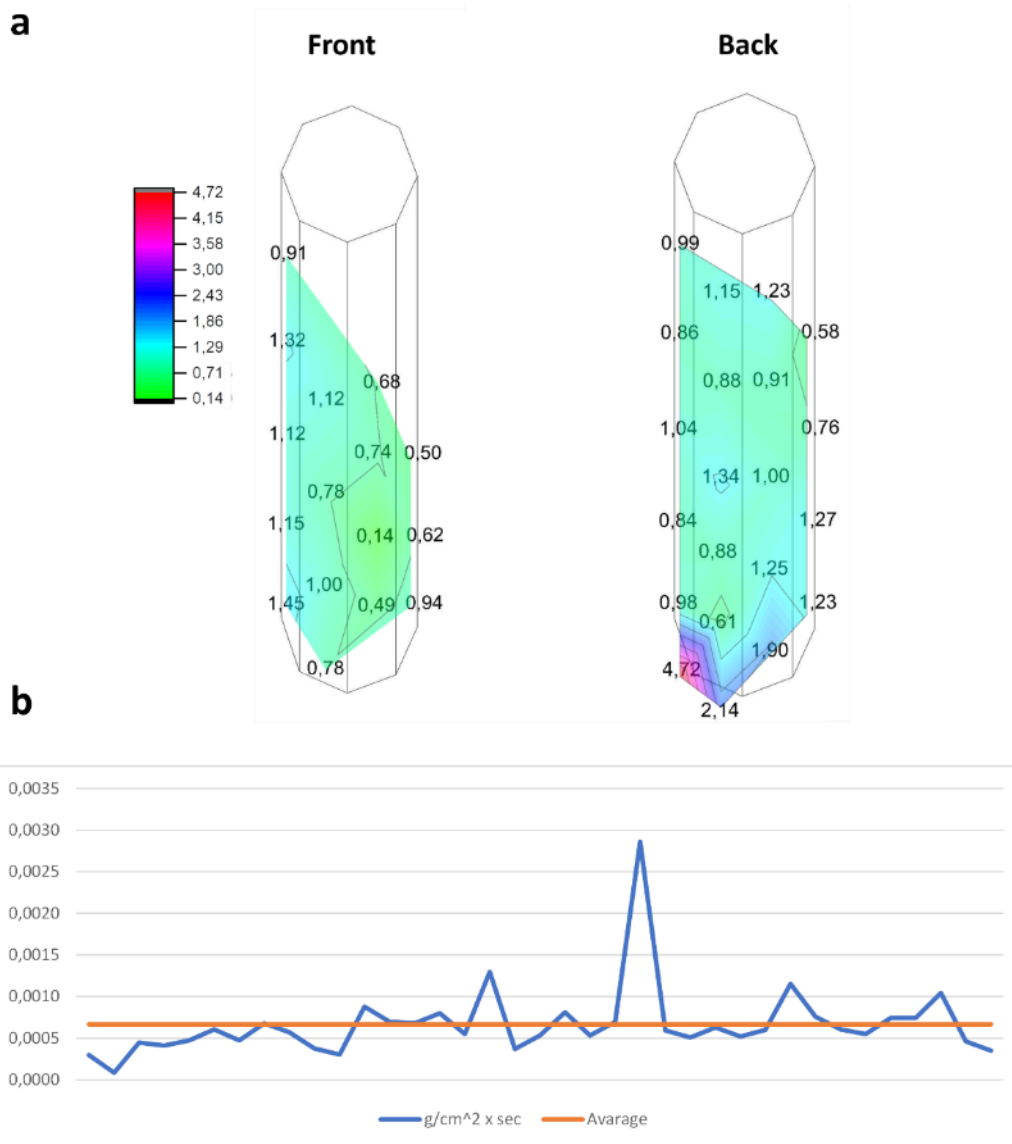
Figure 36. Octagonal column wall of the Proshian family room. a) Colour map based on the sponge-test measurements; b) Resulted values reported in $g/cm^2 \cdot sec$.

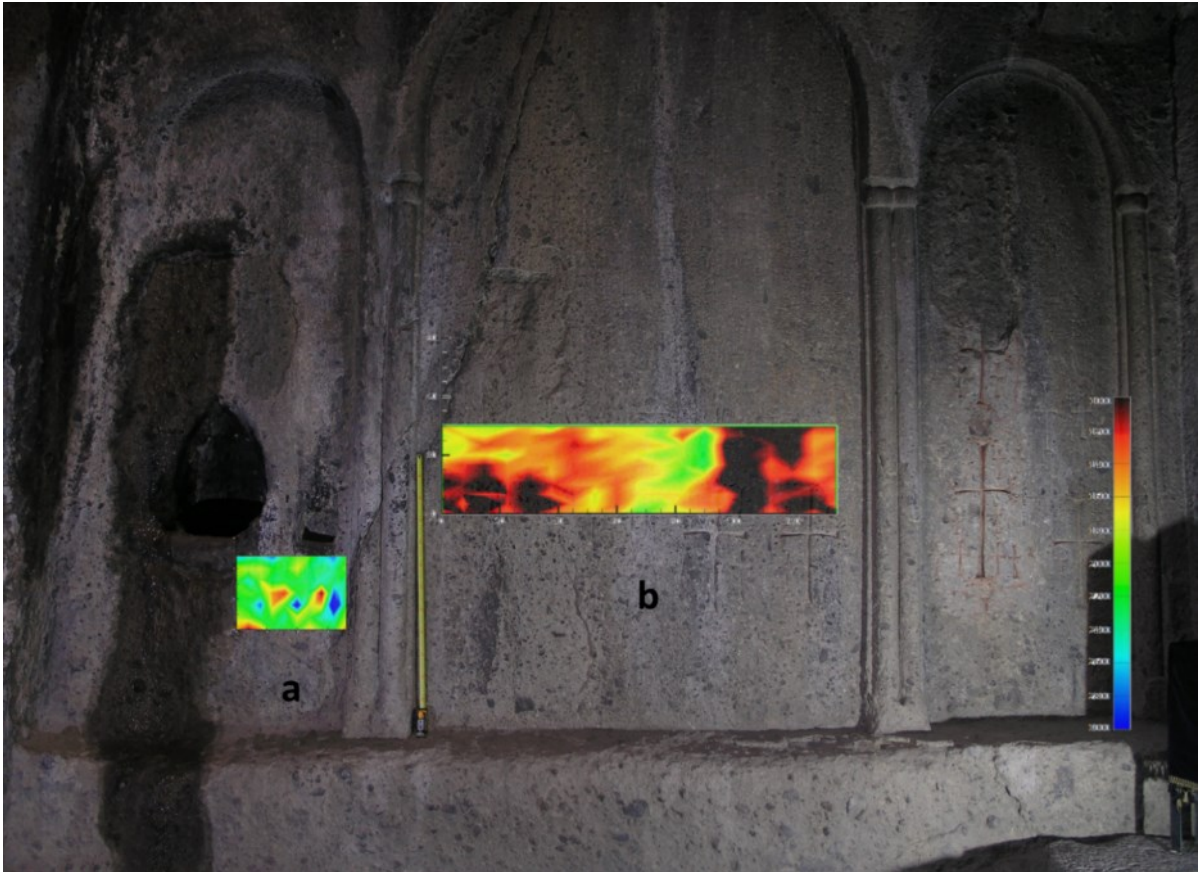
Figure 37. Tomographic results on the western wall area “a” and “b” of the Proshian family room.

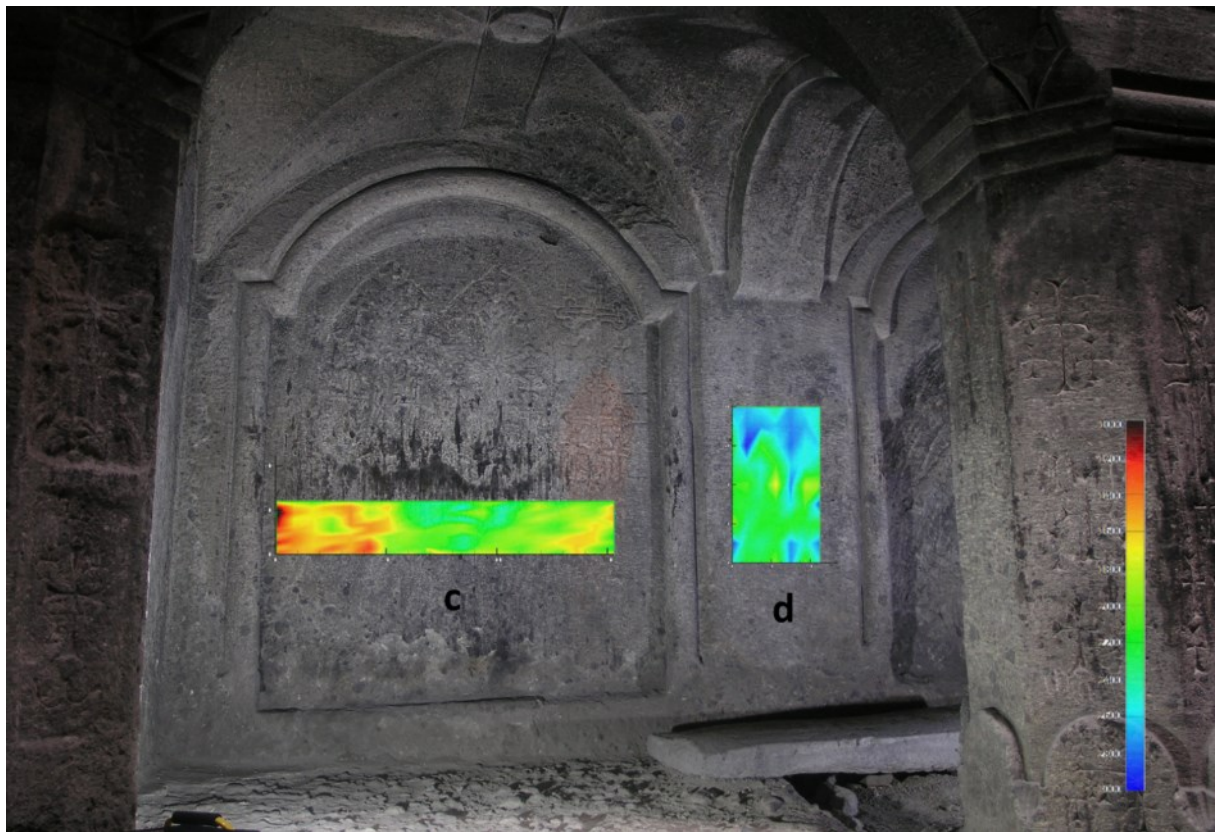
Figura 38. Tomographic results on the western wall area "c" and "d" of the Proshian family room.

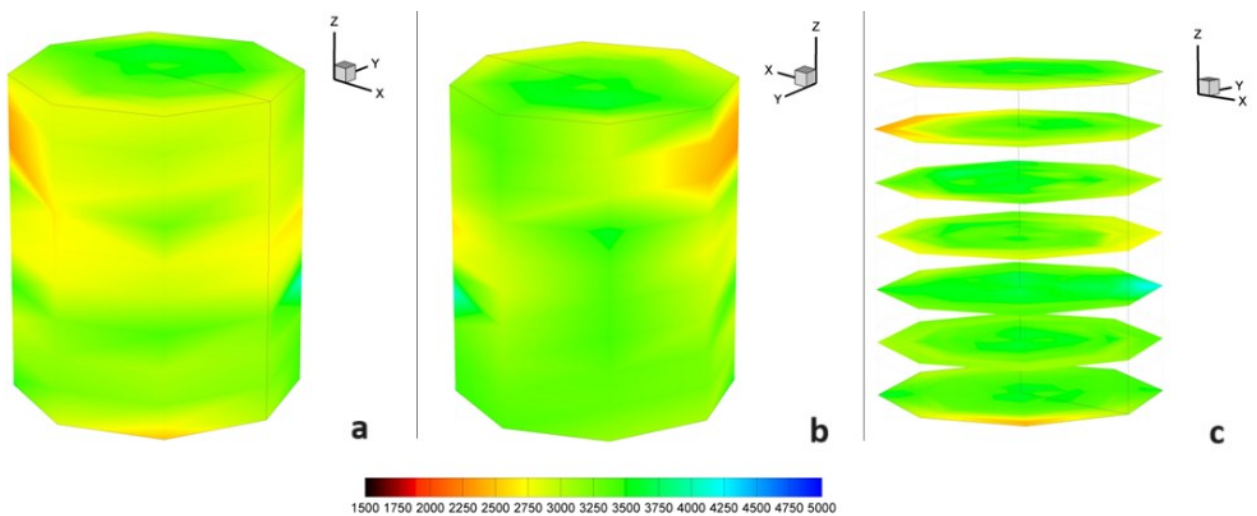
Figure 39. Tomographic results on the octagonal column of the Proshian family room.

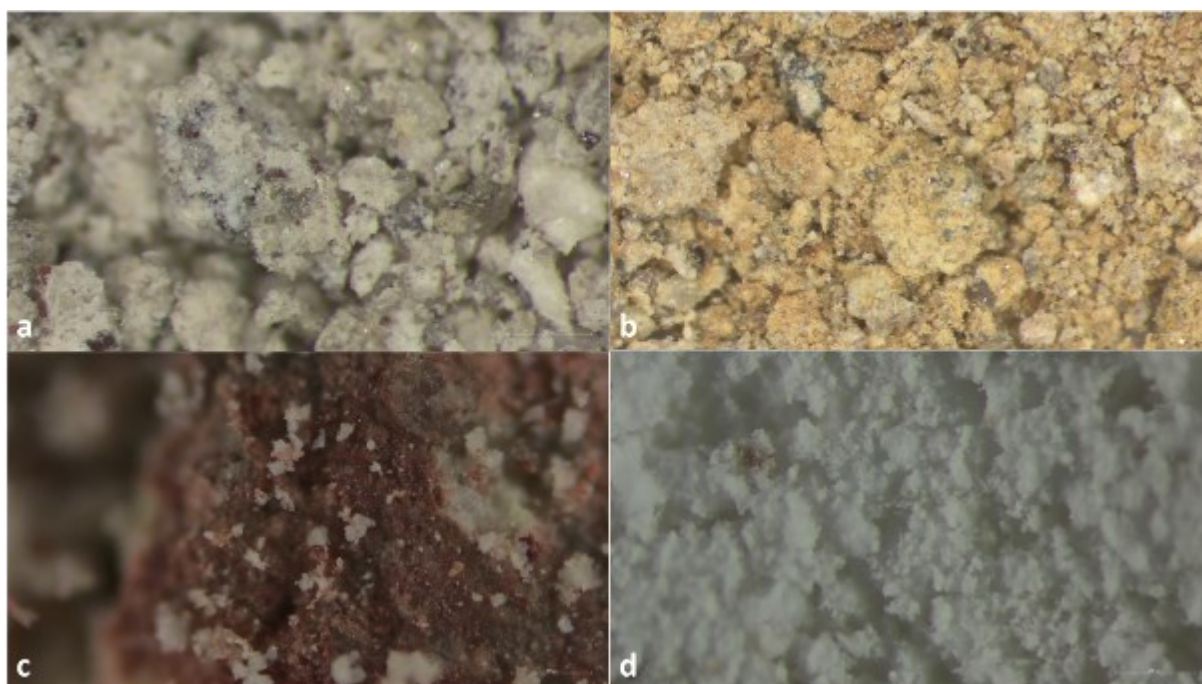
Figure 40. Microscopic pictures of different kind of powders present in the Geghard Monastery. a) sample G_14 6,3x; b) sample G_17 3,2x; c) sample G_6 9,45x; d) sample G_19 9,45x.

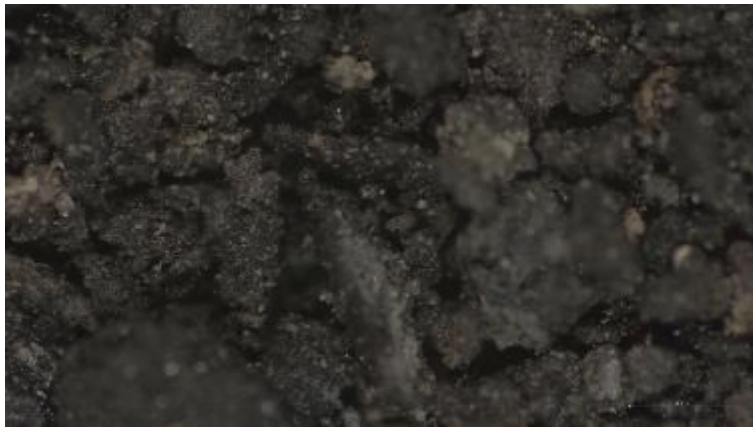
Figure 42. Microscopic picture of black powder, sample G_7 6,3x.

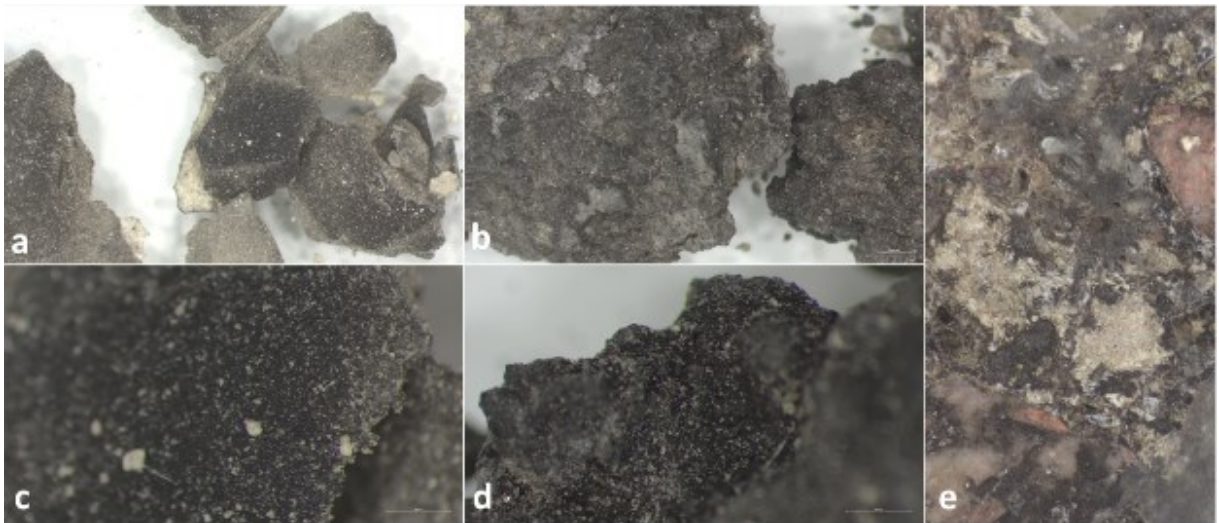
Figure 41. Microscopic pictures of sample G_9 and G_15. a) G_15 1,6x; b) G_9 1,6x; c) G_15 6,3x; d) G_9 6,3x; e) G_9 5x.

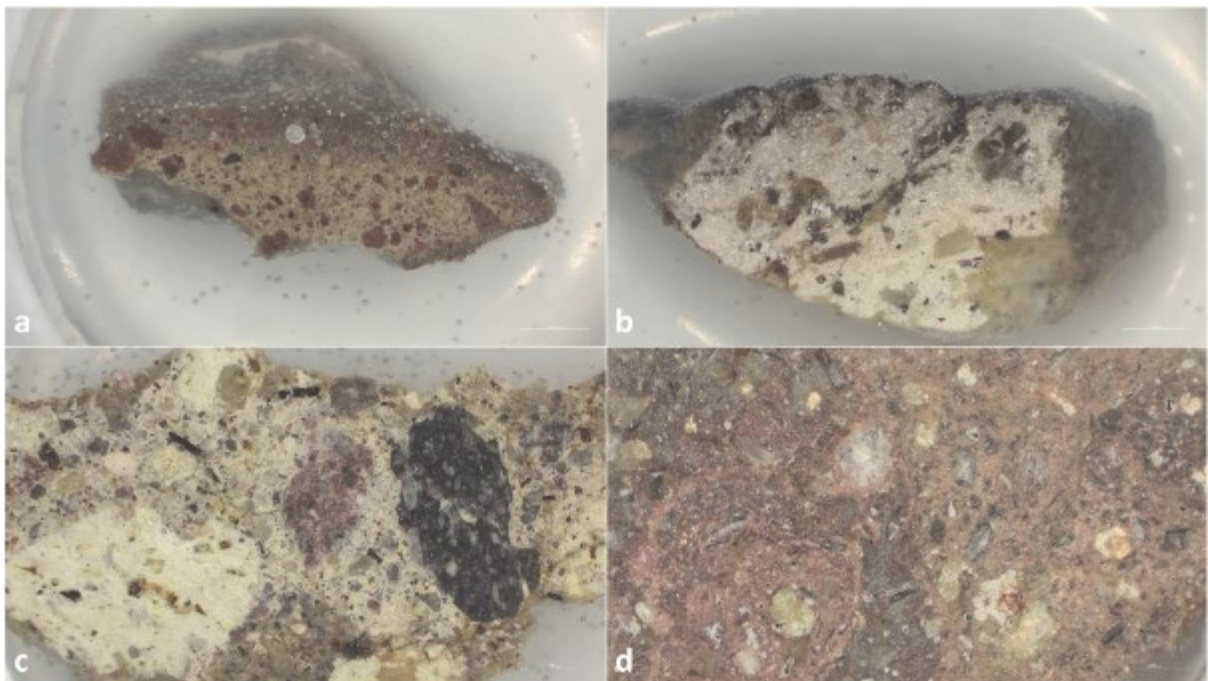
Figure 43. Cross sections microscopic pictures. a) G_2 1,25x ; b) G_13 1,25x ; c) G_5 1,25x ; d) G_22 1,25x.

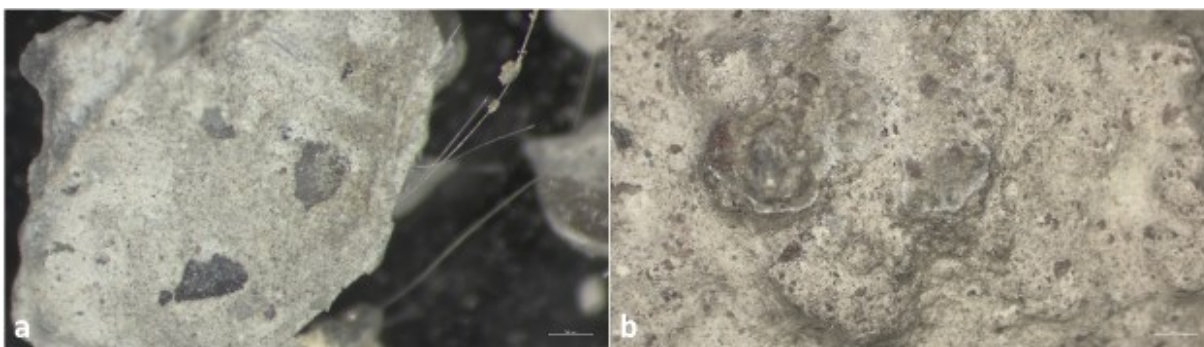
Figure 44. Microscopic picture of sample G_2 and G_2. a) G_20 3,2x; b) G_2 1,6x.

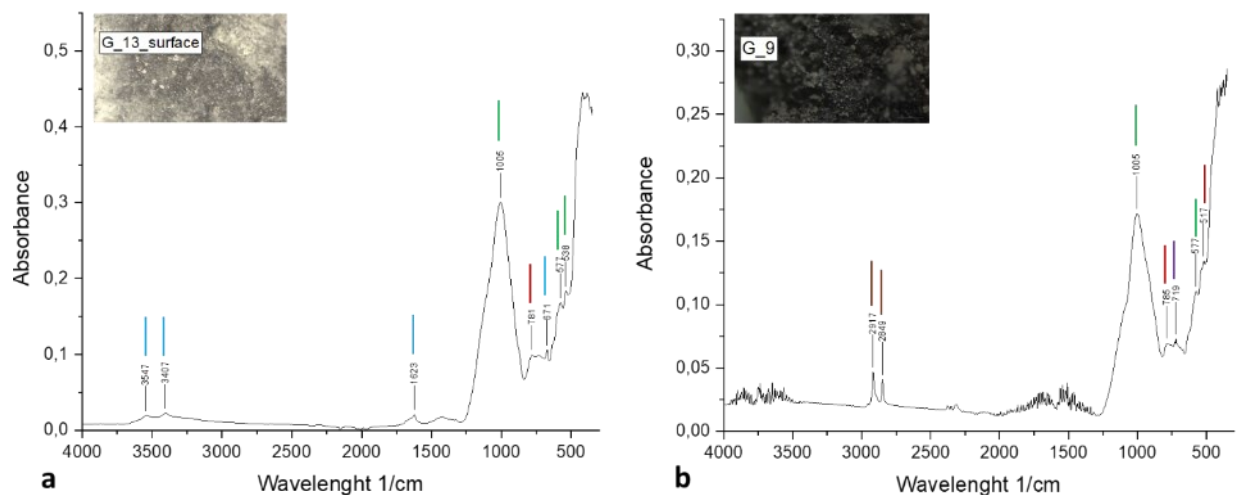
Figure 45. ATR-FTIR spectra of sample G_13 and G_9. a) sample G_13 shows the presence of *gypsum* (3547-3407-1623-671 cm^{-1}), and silicate minerals (*anorthite*? 1005-577-538 cm^{-1} and *quartz*? 781 cm^{-1}); b) Sample G_9 shows peaks associated with *organic fraction* (2917-2849 cm^{-1}), silicate minerals (*anorthite*? 1005-577 cm^{-1} and *quartz*? 785-517 cm^{-1}) and *calcite* (719 cm^{-1}).

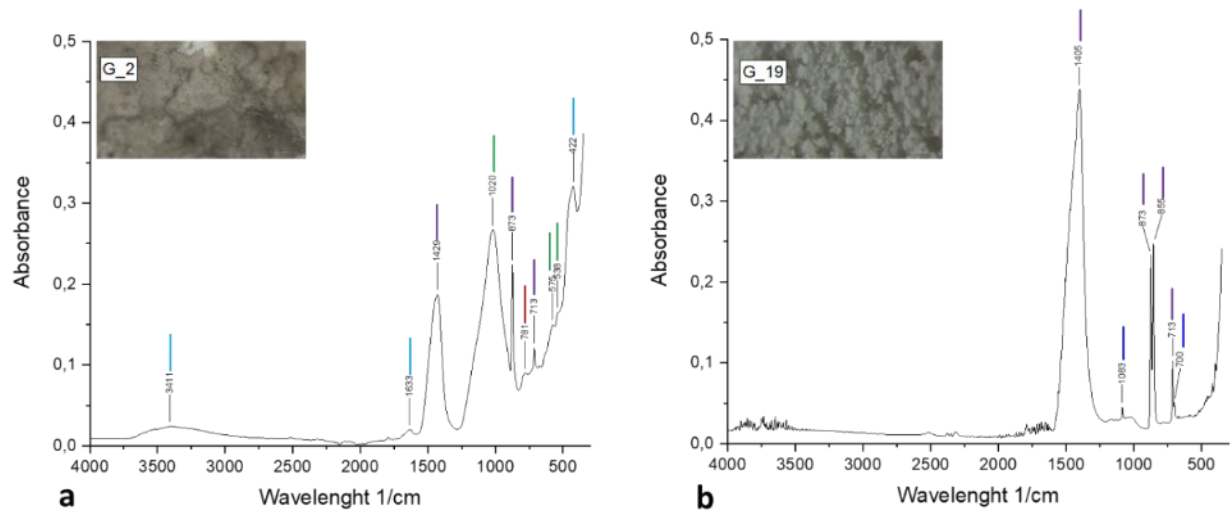
Figure 47. ATR-FTIR spectra of sample G_2 and G_19. a) G_2 shows the presence of *gypsum* (3411 - 1633 - 422 cm^{-1}), *calcite* (1429 - 873 - 713 cm^{-1}) and *silicate minerals* (*anorthite?* 1020 - 575 - 538 cm^{-1} and *quartz?* 781 cm^{-1}); b) G_19 shows the presence of *calcite* (1045 - 873 - 855 cm^{-1}) and *sodium carbonate?* (1083 - 700 cm^{-1}).

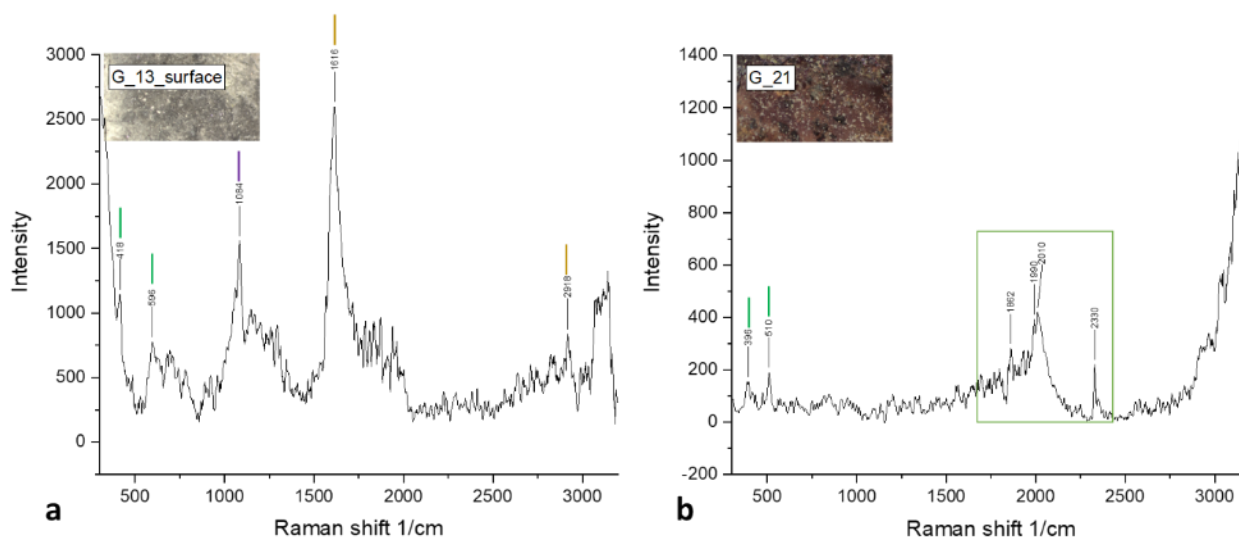
Figure 49. Raman spectra of G_13 and G_21. a) G_13 shows the presence of carbon black (1616-2918 cm^{-1}), calcite (1084 cm^{-1}), and silicate minerals (anorthite? 418-595 cm^{-1}); b) G_21 shows biological patina peaks? (1662-1990-2010-2330 cm^{-1}), and silicate minerals (anorthite? 396-510 cm^{-1}).

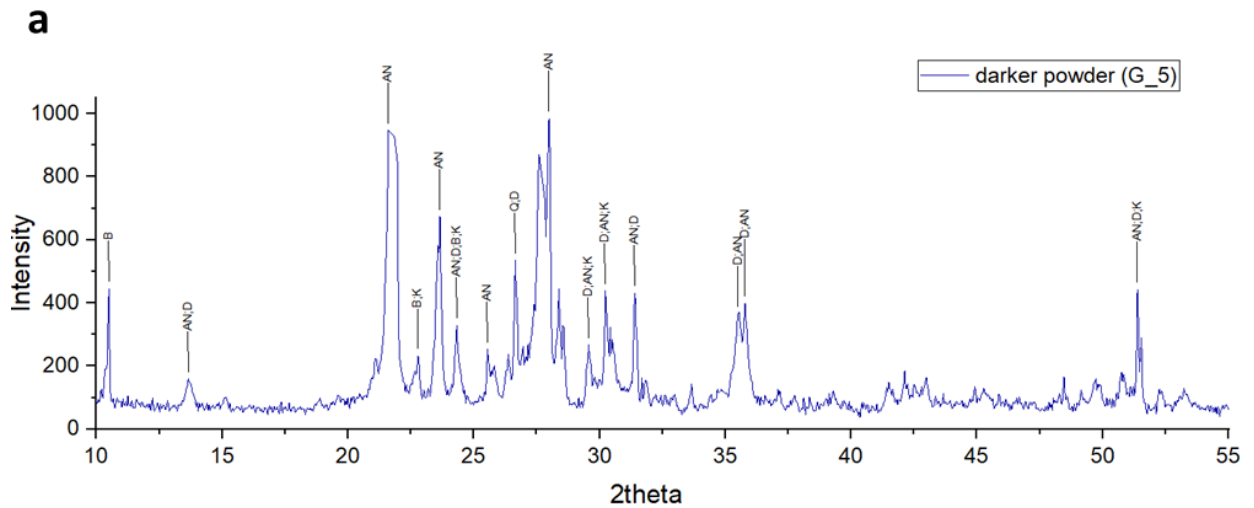
AN: Anorthite (80,4%); B: Biotite (6,2%); K: Kaersutite (4,6%); Q: Quartz (4,6%); D: Diopside (4,1%).

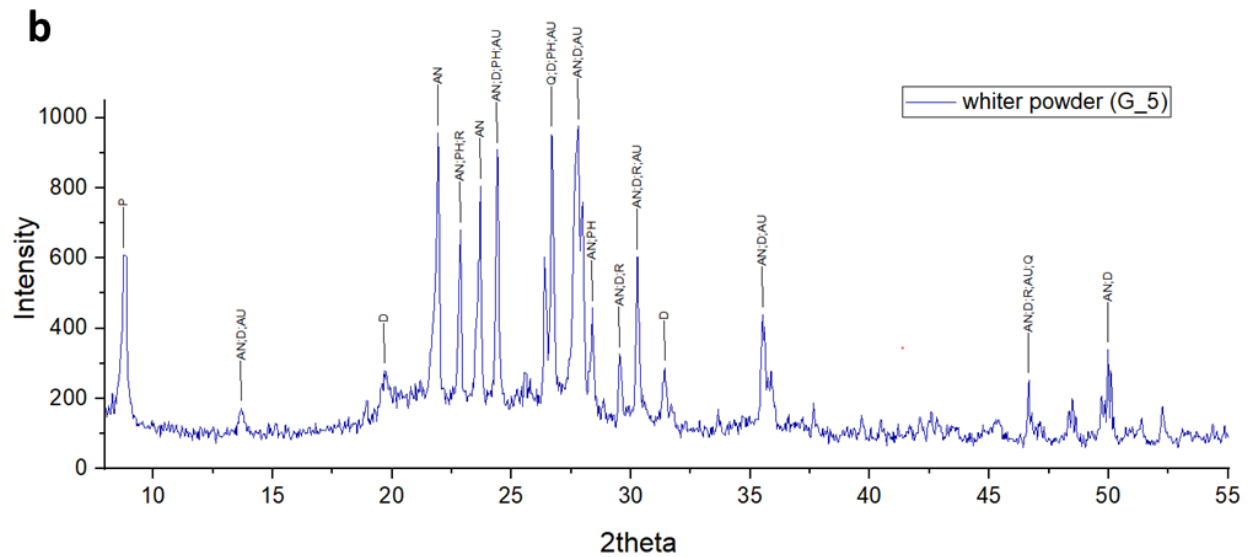
AN: Anorthite (65,9%); PH: Phlogopite (21%); Q: Quartz (8,1%); AU: Augite (2,5%); R: Richterite (1,4%); D: Diopside (1,1%).
